MARINE INVESTIGATION REPORT

M02W0147

CAPSIZING AND LOSS OF LIFE

SMALL FISHING VESSEL *CAP ROUGE II*

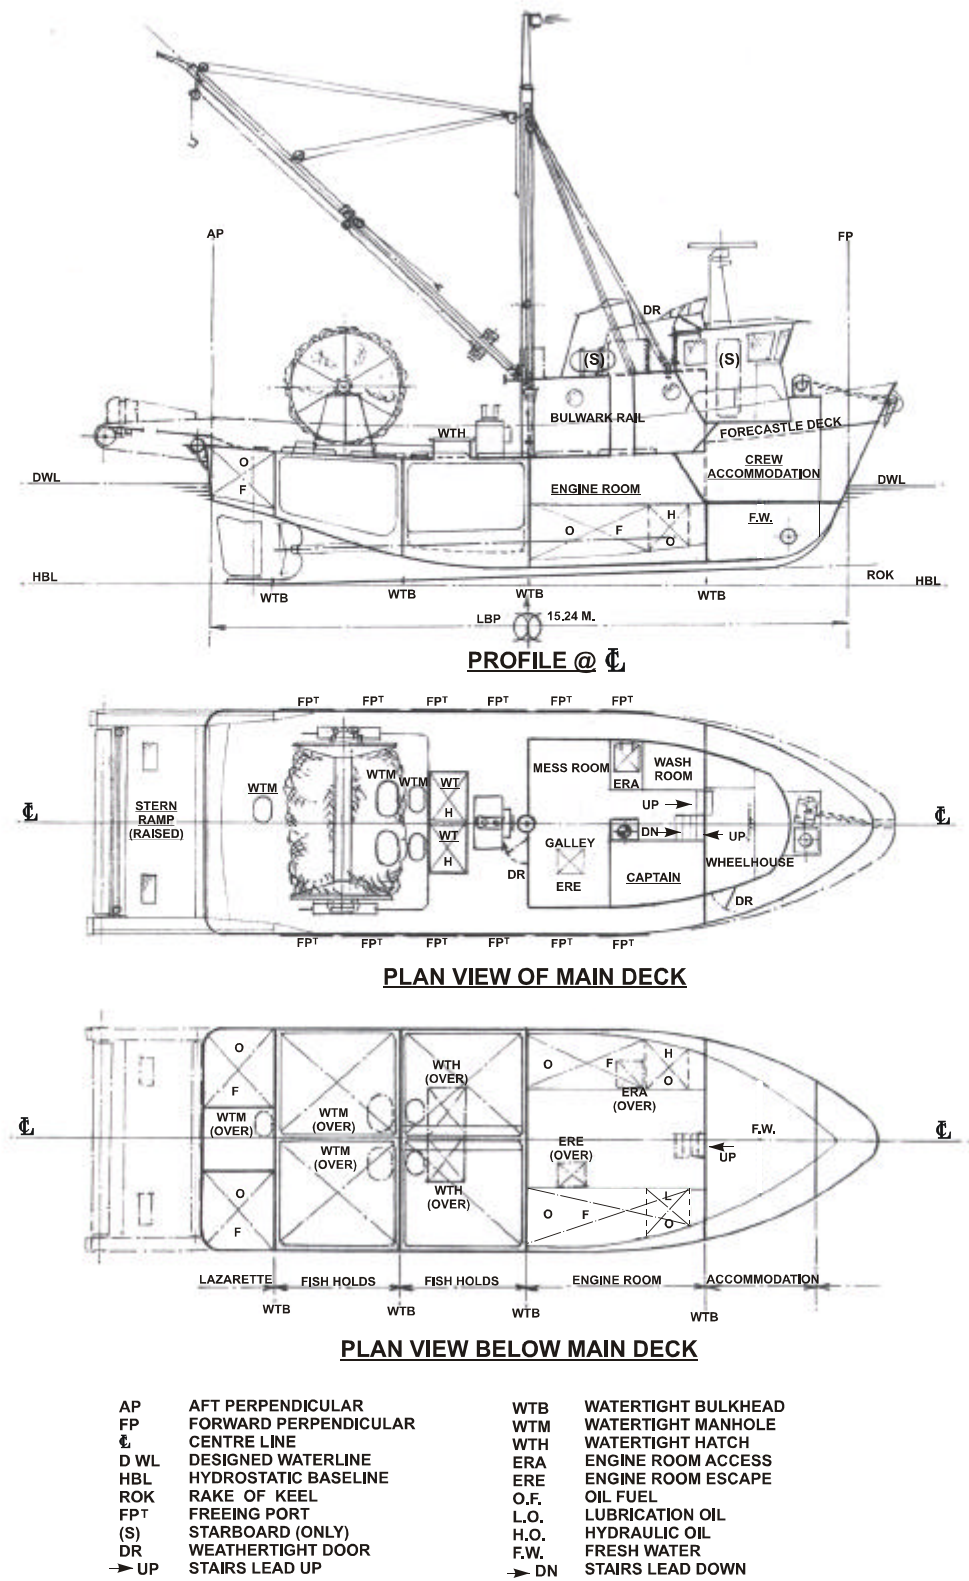
Figure 1. Outline general arrangement

The *Cap Rouge II* was a small fishing vessel of closed construction, having an all-welded aluminum single-chine hull with a transom stern, incorporating an hydraulic fish loading ramp which was generally maintained in the raised position. The hull below the main deck was subdivided by transverse watertight bulkheads, enclosing (from forward) the crew accommodation space, engine room, two forward and two after insulated fish holds divided by a centreline bulkhead, and a lazarette in which the hydraulic steering gear was located. Built-in diesel tanks were arranged on the port and starboard sides of the engine room and the lazarette, and a fresh water storage tank was located under the crew accommodation forward of the engine room. The vessel was powered by a marine diesel engine with a reverse/reduction gear box driving a single fixed-pitch propeller and was fitted with a single plate centreline rudder (see Figure 1).

The fish were stowed in three of four insulated holds (see Figure 1). Each hold was designed to contain a slurry of seawater and ice chips in which the fish were carried to the processing facility. All except approximately 200 pounds of fish were evenly distributed between the two forward holds. The remaining 200 pounds of fish were stowed in the port after hold and none in the starboard after hold. Each of the four holds was partially filled with seawater. The two forward holds were approximately $\frac{2}{3}$ to $\frac{3}{4}$ full and the after holds were approximately $\frac{1}{8}$ full.

There were three means of egress from the combined wheelhouse and deckhouse of the *Cap Rouge II*. A hinged door on the starboard side of the wheelhouse provided egress to one side of the forecandle deck. A combined hinged top hatch and door at the after end of the wheelhouse on the vessel's centreline led to the deckhouse top (see Figure 1). A hinged door in the after end
